### Inspection Report

**Mine Name:** Bull Claim Hill  
**Operator Name:** Sevier County

**Permit number:** S/041/0037  
**Inspection Date:** February 25, 2013  
**Time:** About 6:00-6:30 PM

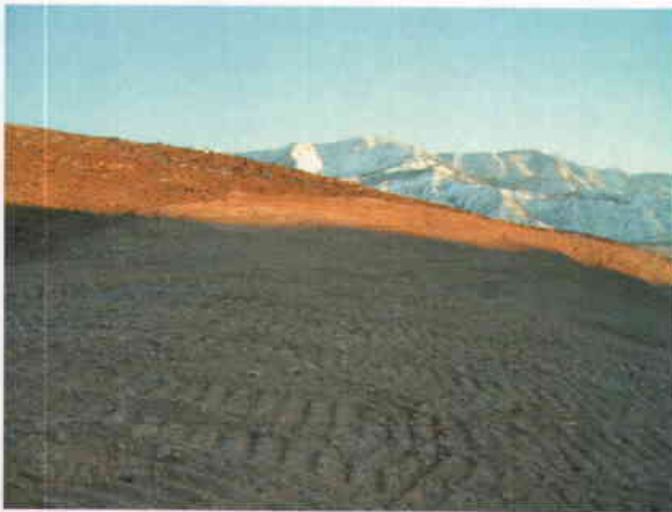
Photo 1

The majority of the site has been regraded and blends nicely with surrounding areas (Photos 1 and 2).

The surface of the regraded areas is roughened with cleat marks, so while it is not extremely rough, it is also not absolutely smooth. I did not look for seeds but hope it was seeded.

The entire area needs to be monitored for revegetation and erosion. In particular the steep slope on the southeast should be checked periodically for erosion.

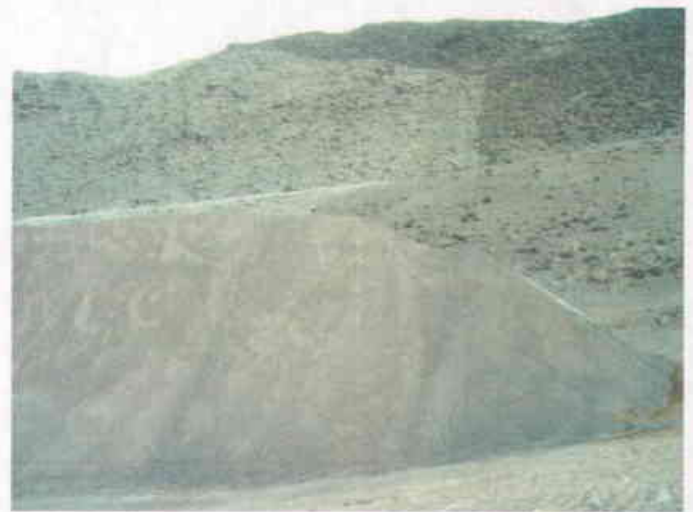
Photo 3

There is one area on the northwest side that still has a stockpile of gravel (Photo 3), and there is one place toward the southeast where the slope is very steep leading into a catch basin (Photo 4).

I did not measure the area with the stockpile but estimate it covers about an acre. The operator would be eligible for release of the regrading portion of the reclamation surety for all but this area.
